Plainview Road / Patchen Woods Subdivision Stormwater Study

BT Engineering, Inc.

March 29, 2011

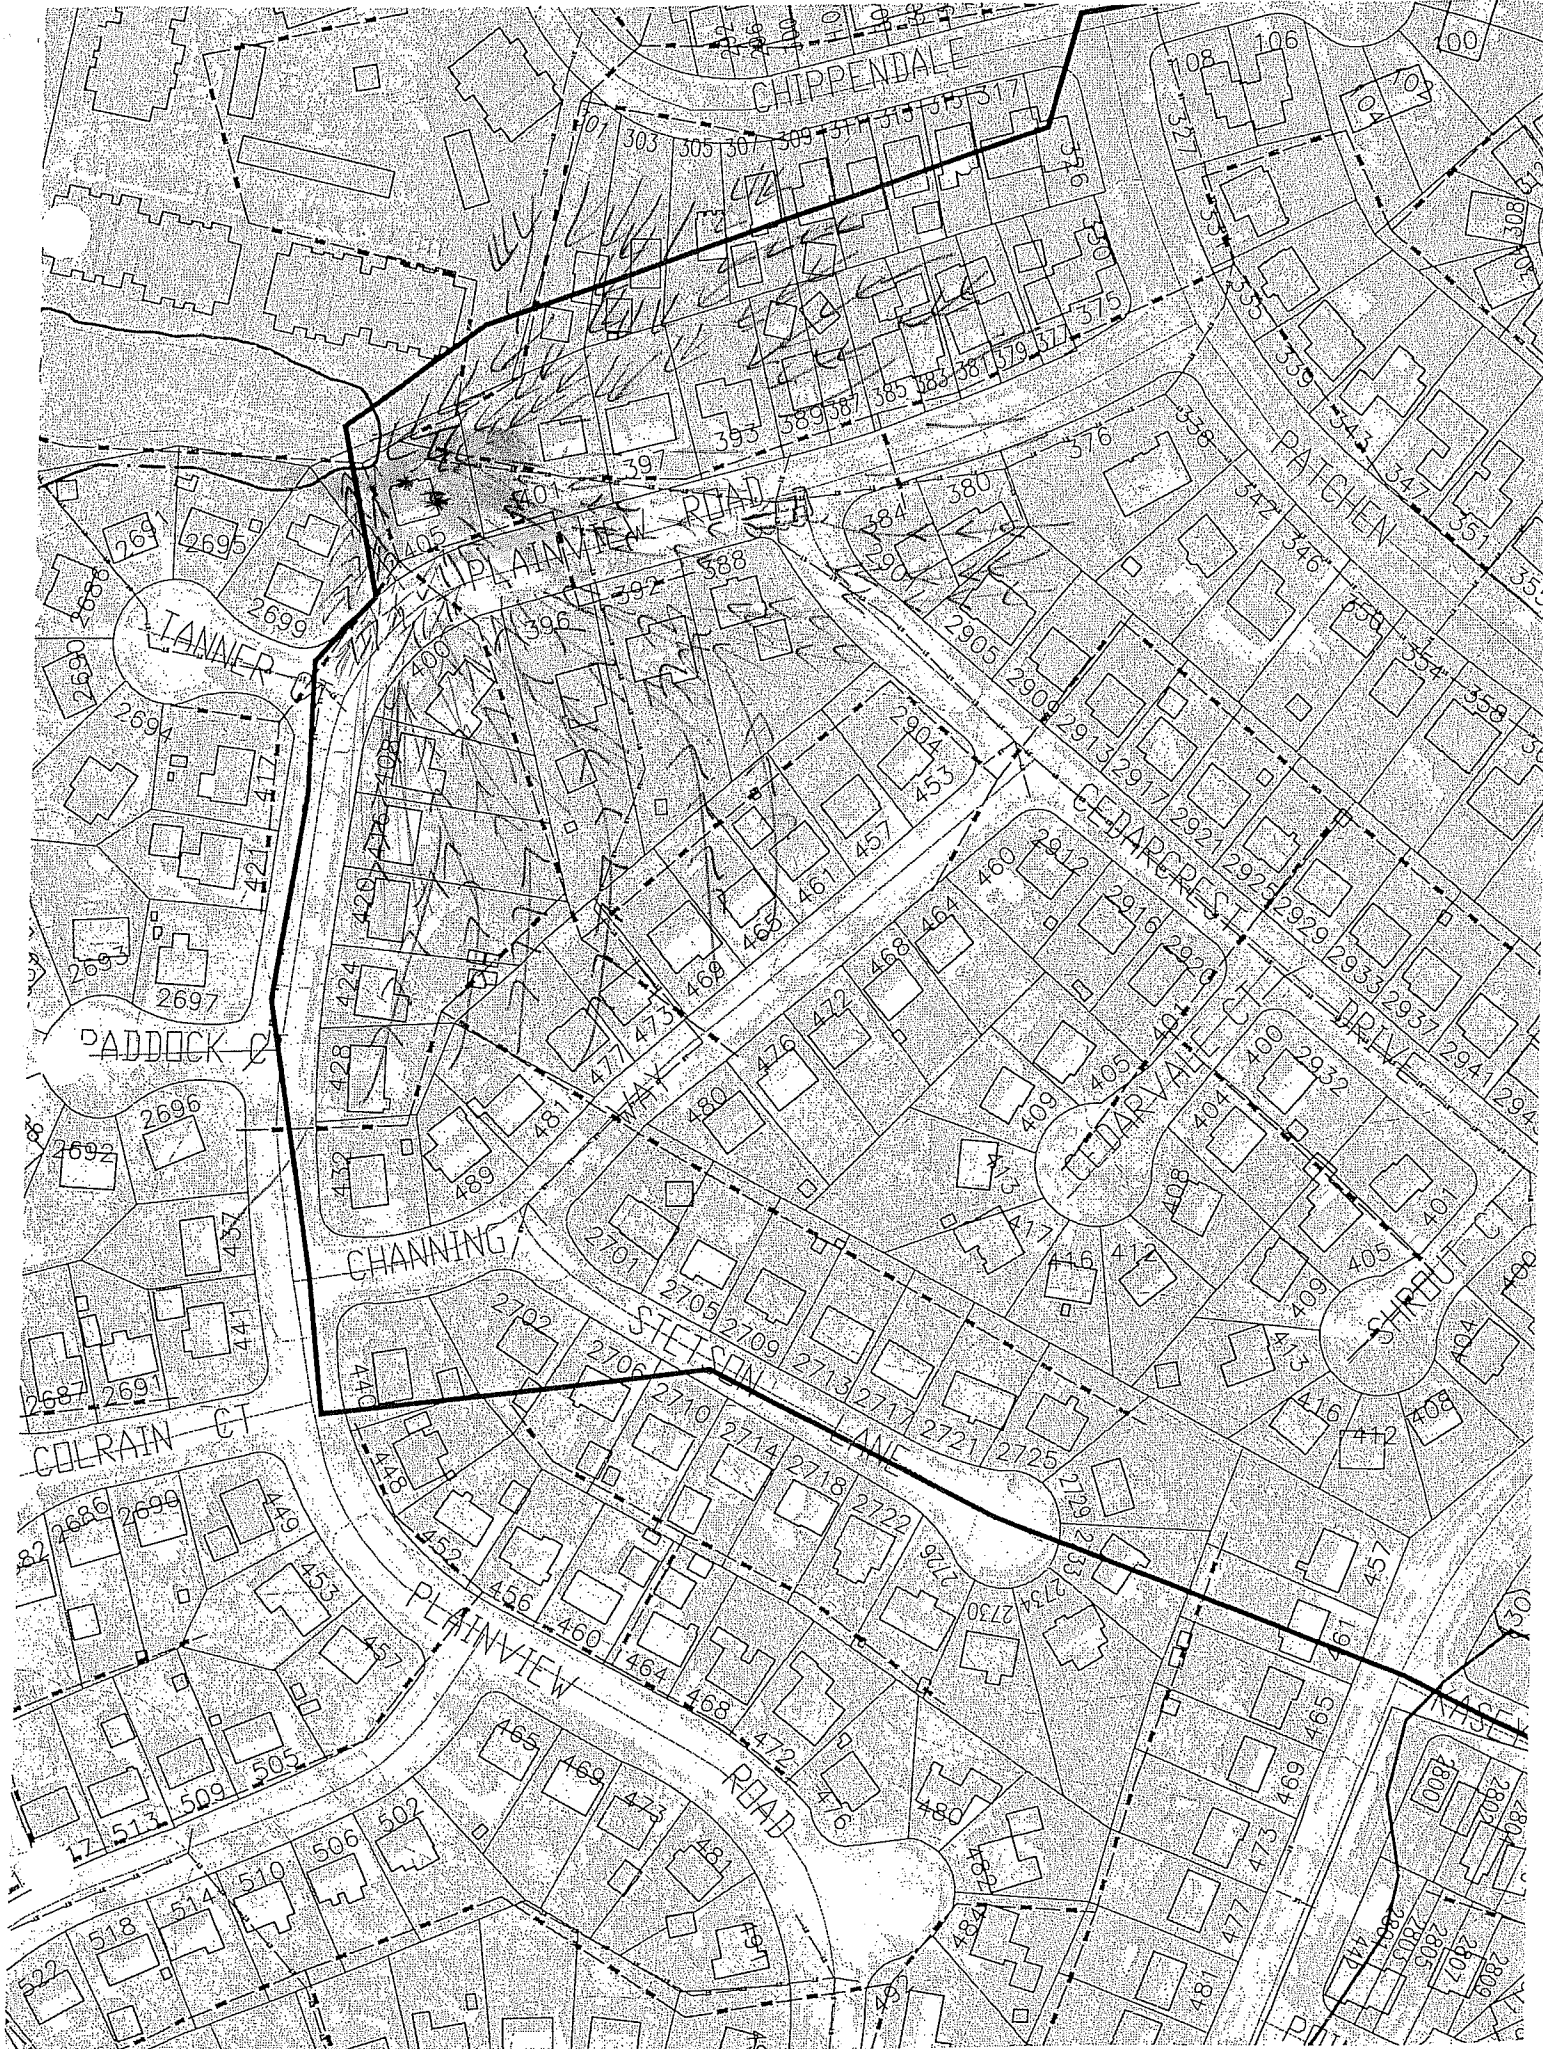
Resident Questionnaire
Stormwater Drainage Issues

The flooding starts from Channing Way, continues to follow the low laying areas from the houses on Plainview (432, 428, 424, 420, 416, 408, 396) and from the property on Channing Way (489, 481, 477, 473) The water will travel through the lower left corner of the property at 424 Plainview and enter the property at 420 Plainview Rd where it will flood the entire back yard from 4'' to 6'' or above. The water will then exit the property at 420 Plainview Rd at the lower left corner and enter 416 Plainview at the lower right corner. The water will then enter at the lower right corner at 416 Plainview and travel through 396 Plainview till it reaches the street at the lowest level of Plainview between 400 – 396 Plainview Rd.
